# SERVICE DIRECTIVE BULLETIN

## SERVICE DIRECTIVE BULLETIN NO. 0115

1. SUBJECT: Trim Relay Replacement

MODEL: 2. All F-28F, 280F, and 280FX models equipped with 24 volt D.C. system;

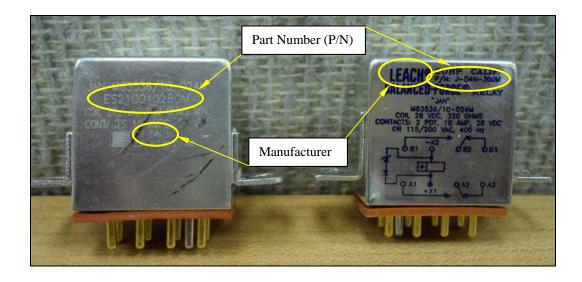
The cyclic trim system utilizes a P/N M83536/10-024M relay to control the trim actuator. This relay is manufactured by various companies under various manufacturers' part numbers. Enstrom has determined that the trim relay, P/N ES2100402BGM, manufactured by DRI Relays Inc. (DRI) has an unacceptably high failure rate. Trim relay P/N J-D4N-300M, manufactured by Leach Corporation (Leach), has performed more reliably.

- A. Remove the seat deck and the copilot side floor panel for access to the trim relay assemblies.
- B. Inspect the trim relays (4 total) for the manufacturer information printed on the unit (Figure 2).
  - 1. If the trim relay is P/N ES2100402BGM, replace the relay with P/N J-D4N-300M.
  - 2. If the trim relay is P/N J-D4N-300M, no replacement is necessary.

Figure 2. Trim Relays (DRI relay shown on left; Leach relay shown on right)

- A. Remove the trim relay bracket.
- B. Remove the relay post nuts.
- C. Pull the relay from the socket.
- D. Install the replacement relay.
- E. Reinstall the nuts.
- F. Reinstall the bracket.
- G. Reinstall the copilot side floor panel and the seat deck.
