SERVICE DIRECTIVE BULLETIN

SERVICE NOTE NO. 0034 Page 1 of 2

Subject: Copilot's Tail Rotor Pedal Clearance with the Defroster Installation Mount Bolt

Model: F-28A Only

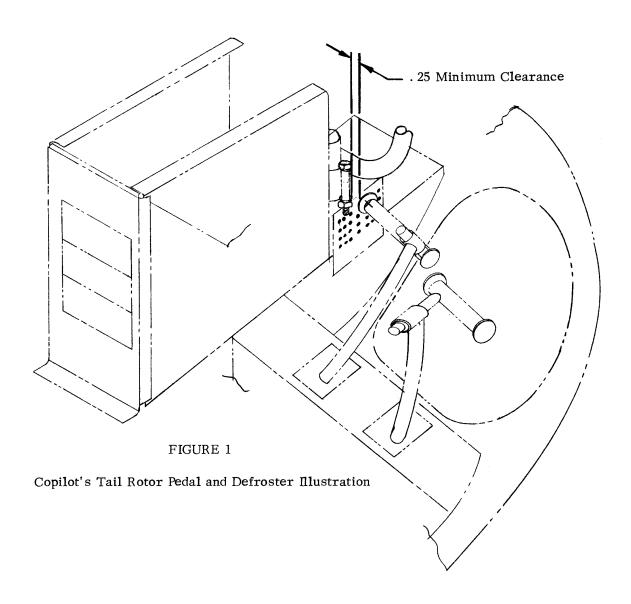
One occurrence has been reported of the copilot's left tail rotor pedal interference with the defroster mount bolt.

- 1. Push the tail rotor pedals to the full left position.
- 2. Push the inboard copilot's pedal laterally toward the center of the helicopter to take up system tolerances.
- 3. Maintaining hand pressure to the left, move the inboard or left tail rotor pedal aft to the stop. The minimum clearance is illustrated on page two, Figure No. 1, of this service note.
- 4. Items 1, 2, and 3 are to be repeated with the tail rotor pedal in all six of the foot adjustment positions.

If any interferences are found, contact Enstrom Customer Service Department for replacement foot supports (2 required).
