SERVICE DIRECTIVE BULLETIN NO. 0046

Subject: Dual Collective Stick Reinstallation

Models: F-28C and 280C

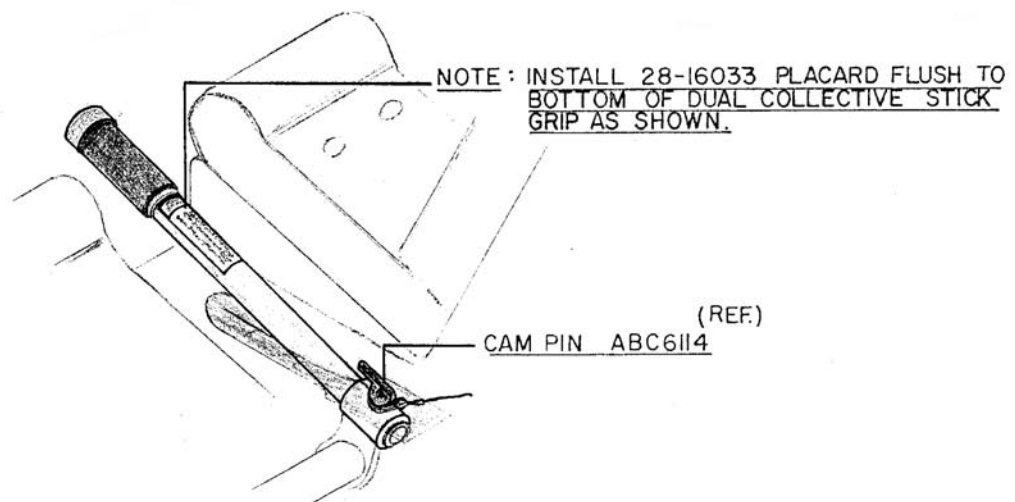
Enstrom has had a field report of a dual collective stick being reinstalled incorrectly allowing the throttle grip to move outward and become disengaged. This occurrence was caused by the cam lock pin not being fully seated into the stick socket and not engaging the internal throttle shaft slot, allowing the internal assembly to move outward.

With dual collective stick installed, check security by pulling on grip. If the stick is secure and properly locked into position, install the enclosed placard on the top surface of the dual collective stick, placing the indicator end adjacent with the aft edge of the throttle grip as shown in Figure 1 below.
