ENSTROM HELICOPTER CORPORATION

SERVICE DIRECTIVE BULLETIN

SERVICE DIRECTIVE BULLETIN 0052
Attachment - Bendix Service Bulletin No. 614

Subject: Repair of Five Wire Connector

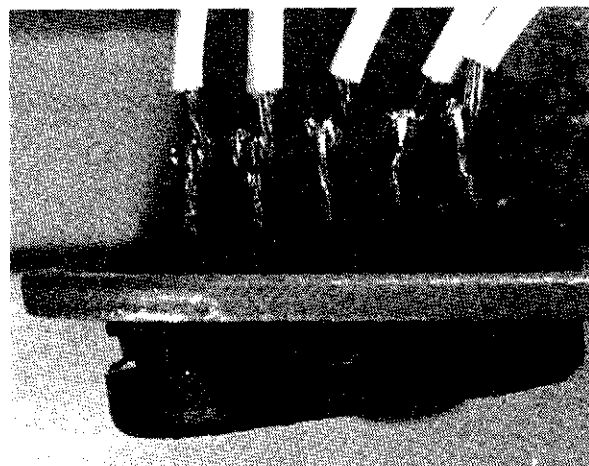
Figure 1 Defect

Bushing (connector), P/N 10-382943, may become loose in the vibrator plate and cause the grounding of both magnetos with possible loss of ignition. See figure 1 (defect).

1. Remove starting vibrator from the airframe.
2. Remove cover to expose the internal surface of the terminal bushing (connector).
3. The surface around the terminal bushing must be clean, dry, free of oil, dirt and grease.
4. Reseat the terminal bushing in the mounting plate to its full extent.
