SERVICE DIRECTIVE BULLETIN NO. 0063

SUBJECT: Possible Bendix Impulse Coupling Defect as noted by Emergency AD issued on or about 9/9/82

MODELS: F-28C prior to S/N 480 (except S/N 465); 280C prior to S/N 1183 (except S/N 1172)

**SERVICE BULLETIN NO. 623
Engineering Aspects are
FAA Approved**

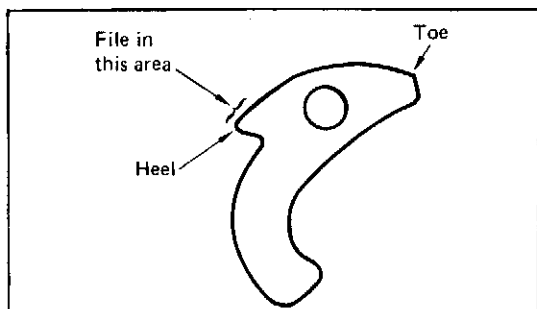
Figure 1

Some improperly heat treated (soft) flyweights have been reported on impulse couplings currently in service. If this condition exists and is not detected, impulse coupling failure could occur, causing possible engine damage or failure. The flyweights must be inspected in accordance with the instructions in this Service Bulletin and if defective (soft) the im-

1. Following published procedures remove the magneto from the engine.
2. Place the magneto in a suitable work stand with the impulse coupling facing up.
3. Use finger pressure to push inward on the toe (see figure 1) of each flyweight so that the flyweight heel protrudes outward.
4. Using a fine # 1, double cut, 1/2 inch wide file, at least 3/32 inch thick, pass the file across the heel of the flyweight attempting to remove material. (See figure 1). If the flyweight has been properly heat treated the file will "glide" smoothly over the heel of the flyweight, removing no material. If the flyweight is not properly heat treated (soft), the file will not "glide" easily across the surface of the flyweight heel, and material will be removed.

5. If an improperly heat treated (soft) flyweight is found, immediately remove and replace the cam assembly and/or the impulse coupling assembly following procedures in the magneto overhaul instructions, and paying strict attention to notes and cautions.
6. Inspect the impulse coupling stop pins for wear and replace as necessary.
7. After flyweights and stop pins have been inspected and the impulse coupling reinstalled on
