ENSTROM HELICOPTER CORPORATION

SERVICE DIRECTIVE BULLETIN

SERVICE DIRECTIVE BULLETIN 0079 PAGE 1 OF 2

1. SUBJECT: Landing Gear Leg Cracks, Enstrom P/N 28-17132-1 thru -4

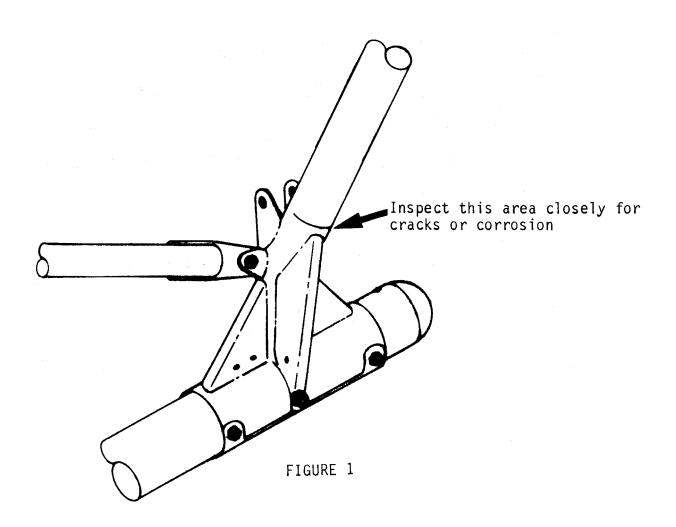
Several instances of landing gear legs (P/N 28-17132) have been found with cracks opposite the lower oleo fitting and adjacent to the upper portion of the bottom gusset. In some instances the gear leg failed at this point during around handling of the helicopter.

In reviewing the failed landing gear legs, it appears that internal corrosion is probably the major contributing factor to these failures. The investigation also indicated that ships that are trailered frequently, utilized in training, utilized on floats at one time or another, or which are not hangared, may be at high risk for this condition. The following mandatory inspection is required by all owner operators.

Prior to the next flight and as a daily preflight thereafter, a close visual inspection of each landing gear leg in the area as noted in figure 1 must be made. Additionally, this inspection must be repeated at 100 hours intervals utilizing a tapping procedure in any area that may exhibit surface blisters or roughness. Any components found with indicated cracks or heavy corrosion must be replaced by an airworthy landing gear leg assembly prior to the next flight
