SERVICE DIRECTIVE BULLETIN NO. 0120

DATE:            April 29, 2015

1.    SUBJECT:    Collective Stick Socket Inspection
2.    MODEL:       F-28A, F-28C, F-28F, 280, 280C, 280F, and 280FX
3.    EFFECTIVITY:    All S/N
4.    BACKGROUND:

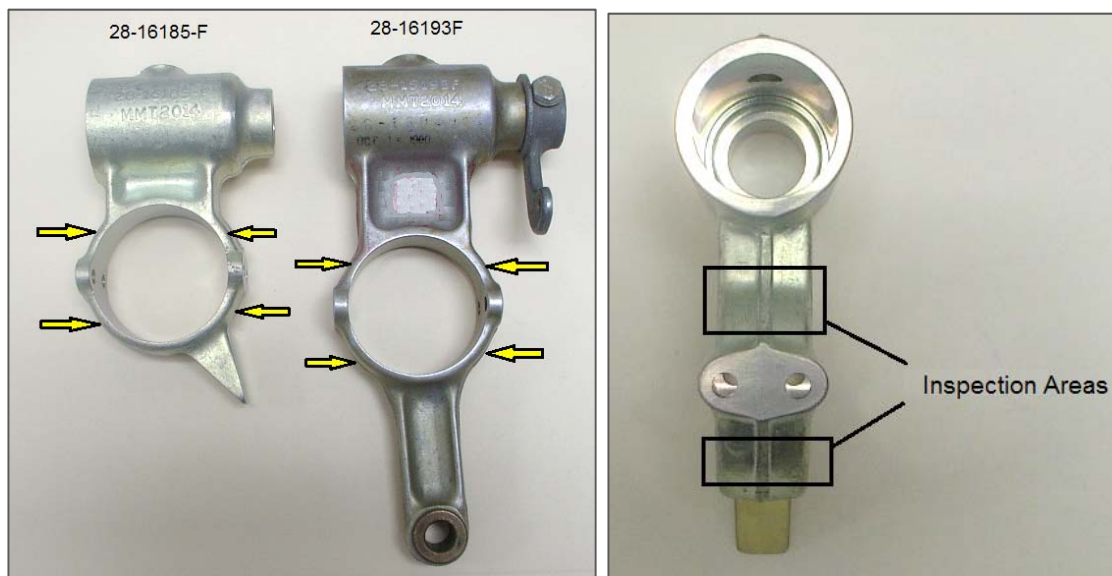
- 6.3 Inspect the collective stick socket for cracks using dye penetrant method. Refer to Figure 1 for the area of the socket to inspect. Inspect all outside surface areas of the socket where indicated by the arrows in Figure 1. The crack will initiate at the edge of the hole for the torque tube and run parallel with the longitudinal axis of the torque tube (or perpendicular to the collective stick). Refer to Figure 2 to see an example of a cracked socket.

Figure 1. Collective Stick Socket Inspection Areas – Inspect for cracks on the surface between the edges of the torque tube hole.

6.3.2 If no bleed-back indications are present, the inspection is satisfactory. Thoroughly clean the collective stick socket per the penetrant kit instructions.

6.3.3 A heavy, solid line bleed-back indicates a crack. Reject the collective stick socket and replace with an airworthy collective stick socket. Use the form on page 9 to record the results of the dye penetrant inspection.

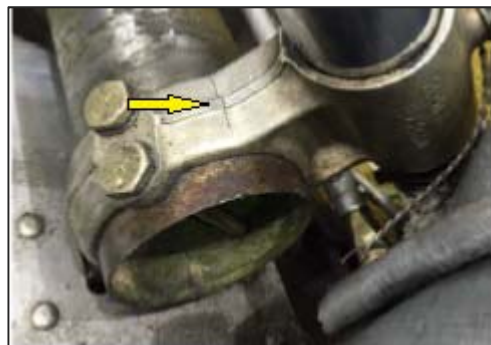
Enstrom has received a report from the field of a cracked pilot-side collective stick socket, P/N 28-16186-1. The crack, discovered during inspection on the ground, was closed initially when detected and then opened easily when the collective stick was moved sideways. Metallurgical analysis determined that the crack was caused by corrosion-assisted fatigue as evidenced by surface pitting and a slight intergranular network of oxide in the microstructure. The collective stick socket was estimated to have been in service for 5,158 hours in a 37 year-old aircraft.

Figure 2. Crack Example (the crack is near the tip of the arrowhead)

6.3.4 Refer to Service Information Letter (SIL) 0183 for replacement instructions.
