ENSTROM

SERVICE DIRECTIVE BULLETIN NO. T-014

1. SUBJECT: Lanyard Installation for Tailcone Vibration Absorber
2. MODEL: TH-28/480
3. EFFECTIVITY: TH-28, S/N 3004 and 3006, and 480, S/N 5001 through 5041, if equipped with the Tailcone Vibration Absorber

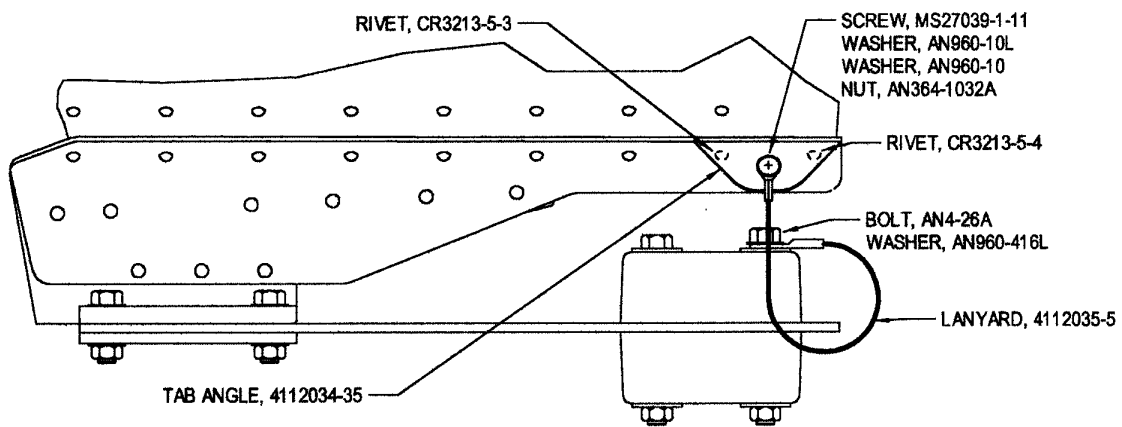
Figure 1. Lanyard Installation

A lanyard has been added to the tailcone vibration absorber assembly to prevent damage or injury to property or persons on the ground in the possible event of a vibration absorber failure.

At or before the next 100 Hour/Annual Inspection, install the lanyard on the tailcone vibration absorber in accordance with Figure 1.

1. Remove the existing rivets as indicated in the illustration above.
2. Place the tab angle into position, open the pilot holes as required using a #20 drill, and install the rivets as indicated.
3. Remove the beam assembly from the aircraft. Install the lanyard onto the beam assembly using the AN4-26A bolt with the AN960-416L washer under the head of the bolt. Torque the bolt to 75 in-lbs (8.5 Nm). Reinstall the beam assembly and torque the mounting bolt assemblies to 75 in-lbs (8.5 Nm).
4. Attach the lanyard to the tab angle using the screw, washers, and nut.
