## SERVICE DIRECTIVE BULLETIN

SERVICE DIRECTIVE BULLETIN NO. T-034

1. SUBJECT: Possible Interference Involving Main Rotor Pitch Change Bellcrank (Cyclic Walking Beam)
2. MODEL: TH-28 and 480 Series
3. EFFECTIVITY: All serial numbers
4. BACKGROUND:

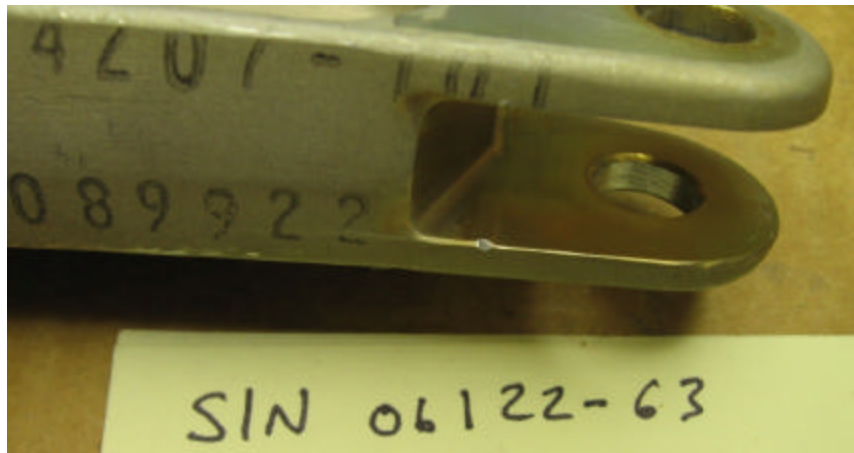
Enstrom received a field report of damaged pitch change bellcranks, P/N 28-14207-101. The damage was caused by interference between the Pitch Change Bellcrank and the end fitting in the Main Rotor Control Rod. This report was from an Enstrom F-28F Model helicopter. This interference only occurs if the collective system is mis-rigged. If the collective system is mis-rigged, the interference may be encountered when the collective is in the full down position and the cyclic stick is moved through a full travel control system check as part of a preflight check. This Service Directive Bulletin is issued because of the collective control system similarities between the F-28/280 Series and the TH-28/480 Series aircraft.

**Figure 1. Damage to ear of bellcrank.**

- A. Remove the Pitch Change Bellcranks from the helicopter following the procedures in the TH-28/480 Series Maintenance Manual.
- B. Replace pitch change bellcranks with damage exceeding .040" / 1.01mm in depth. Using a small file or other suitable device remove the contact damage from the ears of the pitch change bellcranks; blend the repair area over the length of the ear (the repair cannot exceed 0.040" / 1.01mm in depth). Apply a protective coating of epoxy primer (Desoto #593 X 300 or equivalent) to the repair area.
- C. Reinstall the Pitch Change Bellcranks following the procedures in the TH-28/480 Series Maintenance Manual.

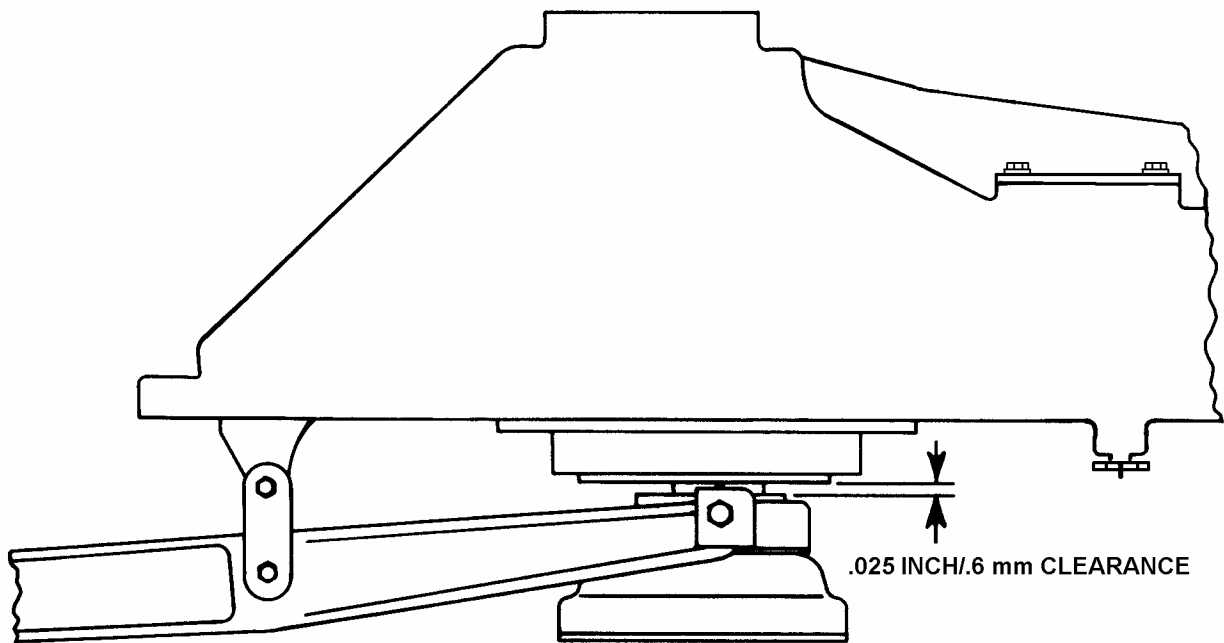
- B. Inspect the rigging of the collective system at the bottom of the main rotor gearbox for .025" (.6 mm) clearance between the collective bearing housing and the swashplate mount flange (See Figure 2). Refer to the TH-28/480 Series Maintenance Manual for the rigging procedures.

**Figure 2. Required clearance between the collective bearing housing and the swashplate mount flange.**
