SERVICE DIRECTIVE BULLETIN NO. T-041

1. SUBJECT: Mounting Hardware Inspection

2. MODEL: TH-28, 480, 480B

3. EFFECTIVITY: S/N 5147 and prior

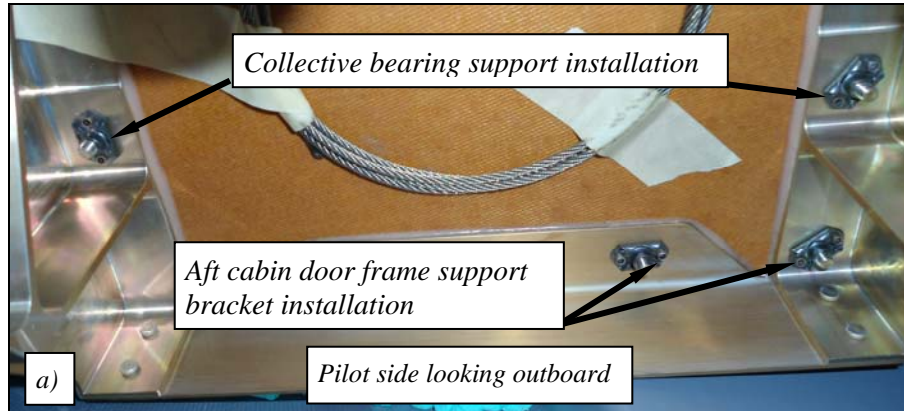
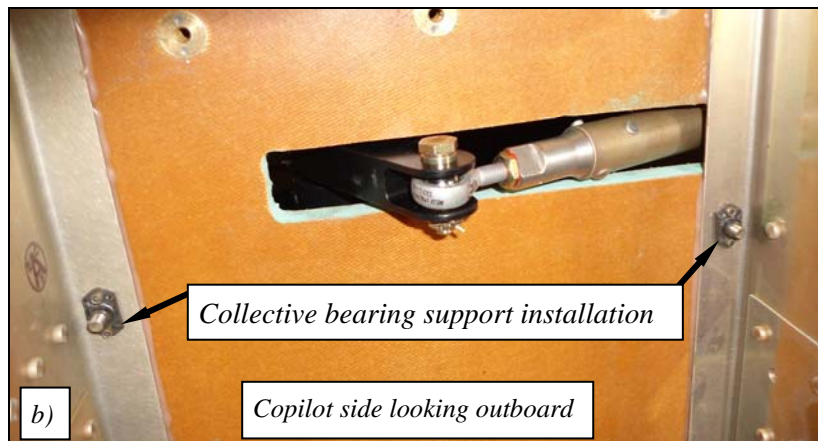
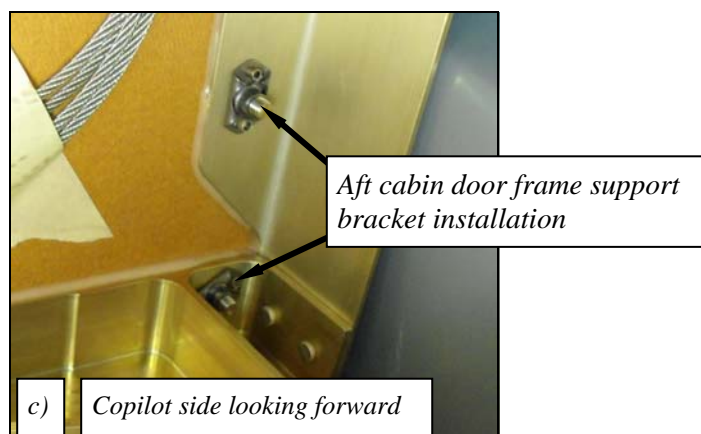
Enstrom has received a report of inadequate thread engagement in the hardware used to install the collective torque tube bearing supports to the keel structure. This was initially discovered on an aircraft when the pilot side bearing support appeared to have movement. Upon further examination, the movement was caused by a lack of thread engagement of an attachment bolt with the nutplate, which counteracted the self-locking feature of the nutplate and allowed the bolt to lose torque. Enstrom has modified the installation incorporating longer bolts to ensure sufficient thread engagement.

During the examination it was also observed that the hardware used to mount the aft cabin door frame support brackets had inadequate thread engagement as well.

Figure 1. View of cabin floor underside and surrounding keel structure: *a)* aft cabin door frame support bracket installation and collective torque tube bearing support installation (pilot side looking outboard), *b)* collective torque tube bearing support installation (copilot side looking outboard), and *c)* aft cabin door frame support bracket installation (copilot side looking outboard).

6.2.1 Collective torque tube bearing supports (*Figure 1a and 1b*)

6.2.2 Aft cabin door frame support brackets (*Figure 1a and 1c*)

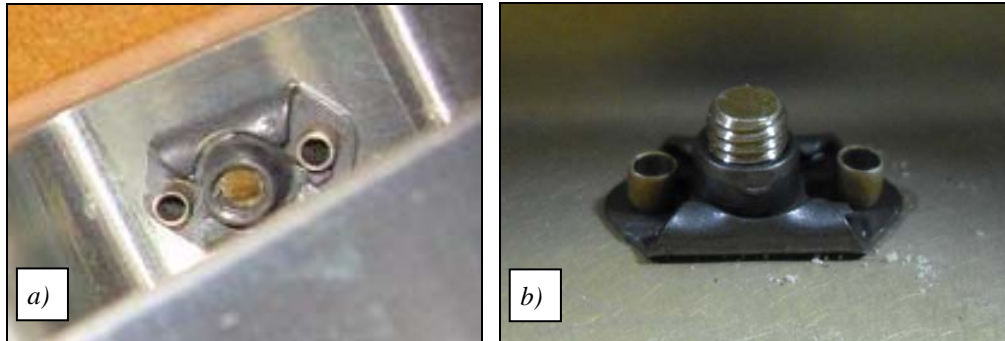
- 6.3 Inspect all bolt or screw attachments for complete thread engagement. At least one thread should be exposed beyond the nut. *Figure 2a* shows an example of inadequate thread engagement. *Figure 2b* shows an example of adequate thread length.

Figure 2. Thread engagement: *a)* inadequate thread engagement and *b)* adequate thread engagement.

- 6.4 If thread engagement is adequate, no additional inspection is required. Re-install the access panels.
- 6.5 If thread engagement is not acceptable, proceed to paragraph 6.6 to replace the bolt(s) or screw(s).
- 6.6 Collective bearing supports
- 6.6.1 Replace the applicable bolt(s) in accordance with *Figure 4*.
- 6.7 Cabin support brackets
- 6.7.1 Aft cabin support brackets: Use P/N MS27039-1-16 for the location with the sheet metal bracket. Use P/N MS27039-1-17 for the location with the machined fitting. See *Figure 3*.
