SERVICE DIRECTIVE BULLETIN NO. T-063

1.    SUBJECT:    Cargo Hook Extension Link Inspection

2.    MODEL:        480 and 480B

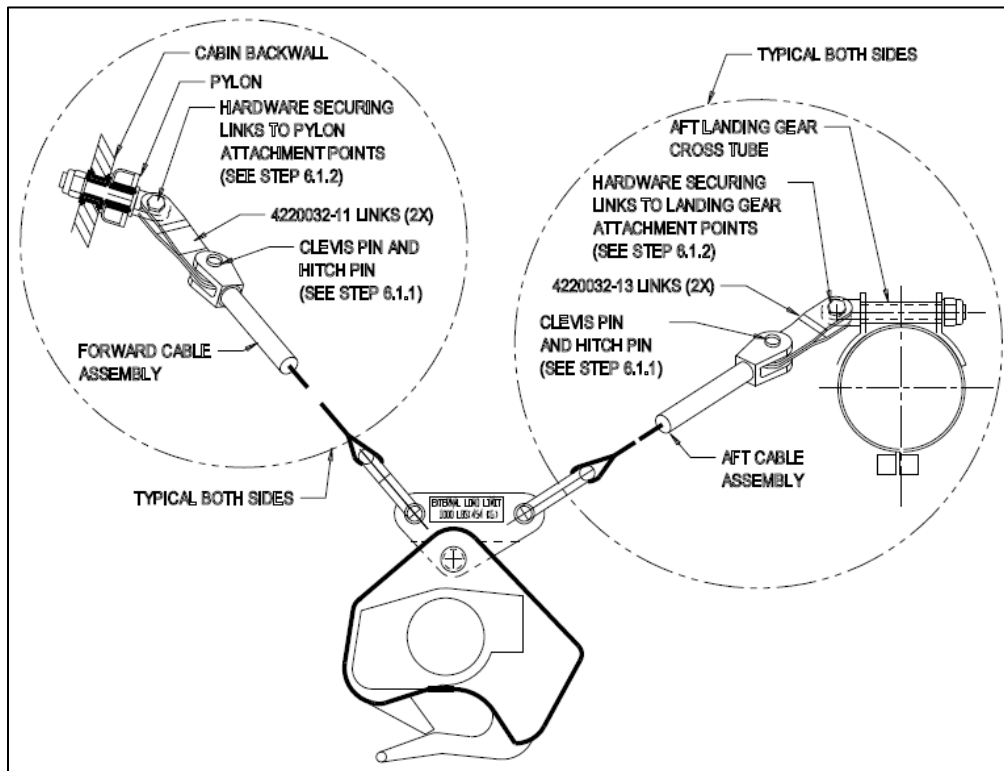
Figure 1. Cargo hook extension link layout

Enstrom has detected a potential issue with the material used in the cargo hook extension links that may result in failure on the cargo hook installation. Failure of these links may cause a detachment of a cable resulting in damage to the aircraft, potential loss of cargo hook load, and damage or injury to persons or property on the ground. Aircraft that are exposed to heavy cargo hook operations are most at risk.

- 6.1.1 Remove the four clevis and hitch pins at the upper end of all cargo hook cables as shown in Figure 1, and place the cargo hook and cables aside.

- 6.1.2 Remove the hardware securing each pair of 4220032-11 and 4220032-13 links from the pylon and landing gear attachment points, respectively, and remove the four pair of links.

- 6.2.4 If deformation, distortion, or cracks are present, or if the hole is larger than .406 in. (10.3 mm) in any direction, replace the 4220032-11 link with a 4220032-15 link and/or the 4220032-13 link with a 4220032-17 link before further use of the cargo hook.

- 6.3.1 Attach the 4220032-11 (4220032-15 if replaced) links in pairs to the pylon attach points using the hardware removed in step 6.1.2 (see Figure 1).
- 6.3.2 Attach the 4220032-13 (4220032-17 if replaced) links in pairs to the landing gear attach points using the hardware removed in step 6.1.2 (see Figure 1).
- 6.3.3 Torque all of the hardware to 95-110 in-lbs/10.7-12.4 Nm.
- 6.3.4 Install the cargo hook, cables, clevis pins, and hitch pins removed in step 6.1.1.
