SERVICE DIRECTIVE BULLETIN

SERVICE DIRECTIVE BULLETIN (SDB) NO. T-065

DATE: October 13, 2020

1. SUBJECT: Transmission Mount - Pylon Joint Cracks
2. MODEL: 480, 480B
3. EFFECTIVITY: S/N 5254 and prior
4. BACKGROUND:

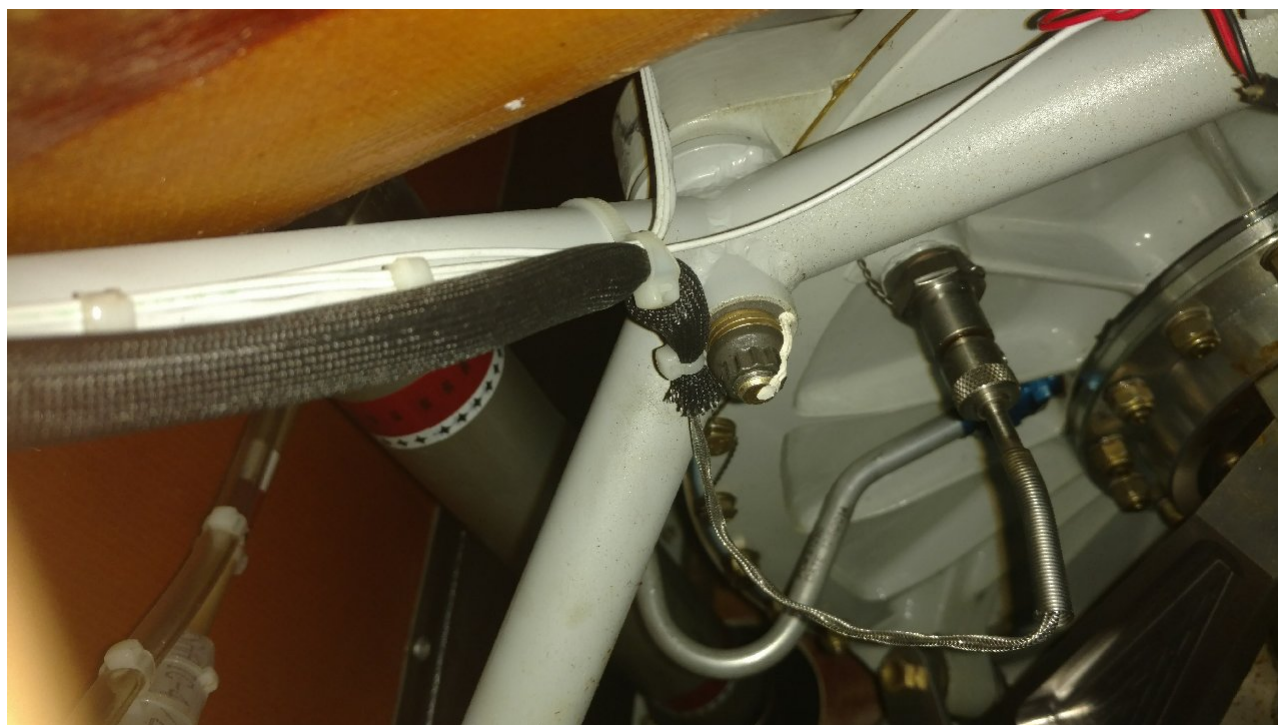
**Figure 1. Photograph of Forward Left Mount with Transmission Installed
(Photo taken through engine access door)**

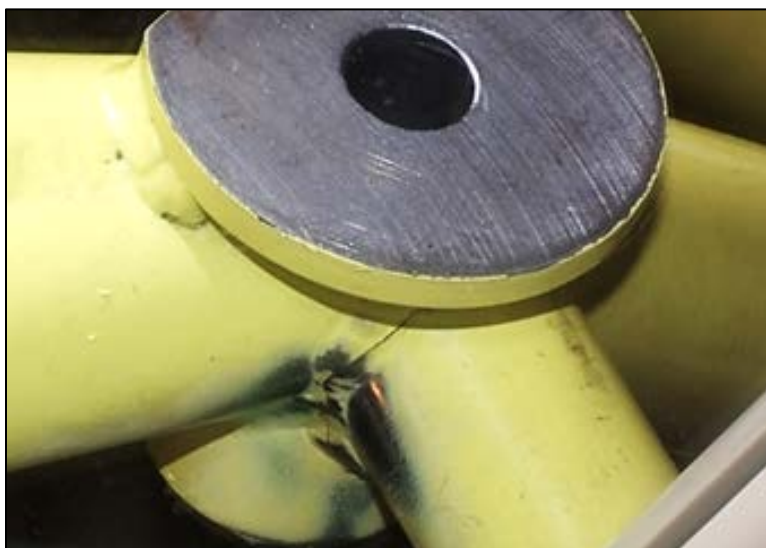
Enstrom has received reports of cracks in the pylon joint under the forward left and right transmission mounts of three aircraft used in training operations. This SDB requires visual inspection for cracks in the pylon joint under each forward transmission mount.

**Figure 2. Photograph of Cracked Area – Forward Left Mount
(Photo taken using a mirror)**

- 6.1 Access the forward pylon transmission mounts through the engine access doors.
- 6.2 Clean the pylon tubes and welds in the area of the transmission mount using a suitable solvent (refer to paragraph 7.1).
- 6.3 Using a borescope, light source, inspection mirror, as available, inspect the pylon tubes and joint welds for cracks (Figure 1 through Figure 6).
- 6.4 If an area is suspect, use a liquid penetrant method (ASTM E165) to confirm the presence of a crack.
 - 6.4.1 Enstrom Product Support may be contacted for assistance evaluating the indications from the liquid penetrant inspection.
- 6.5 If cracks are detected, contact Enstrom Product Support for the repair procedure.

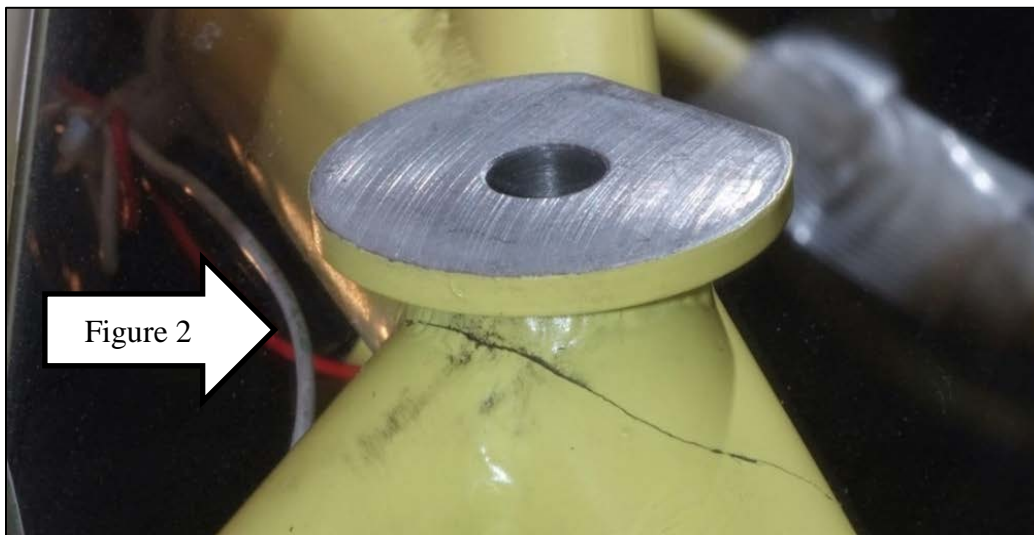
**Figure 3. Photograph of Cracked Area – Forward Left Mount - Rotated 90°
(Photo taken using a mirror)**

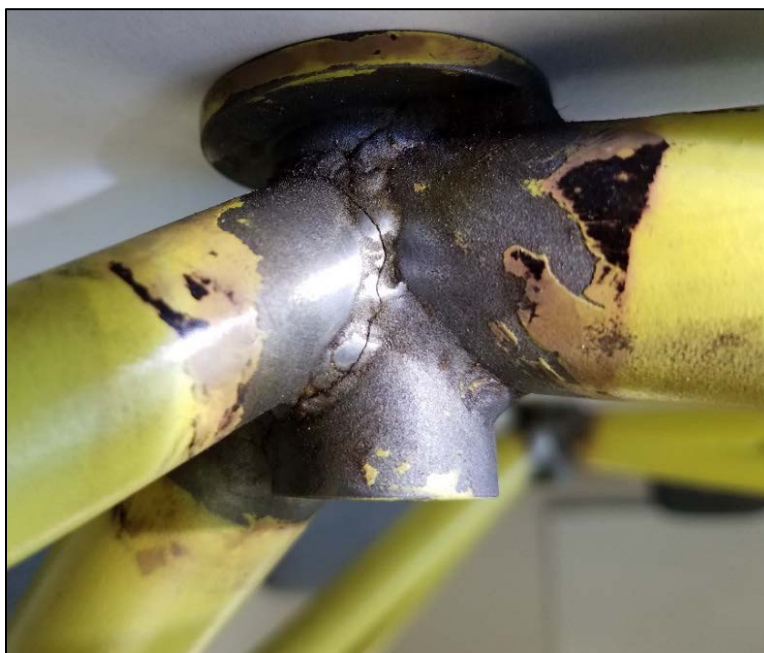
**Figure 4. Photograph of Cracked Area – Forward Left Mount
(Same area as in Figure 2 except mirror was not used; paint/epoxy primer removed)**

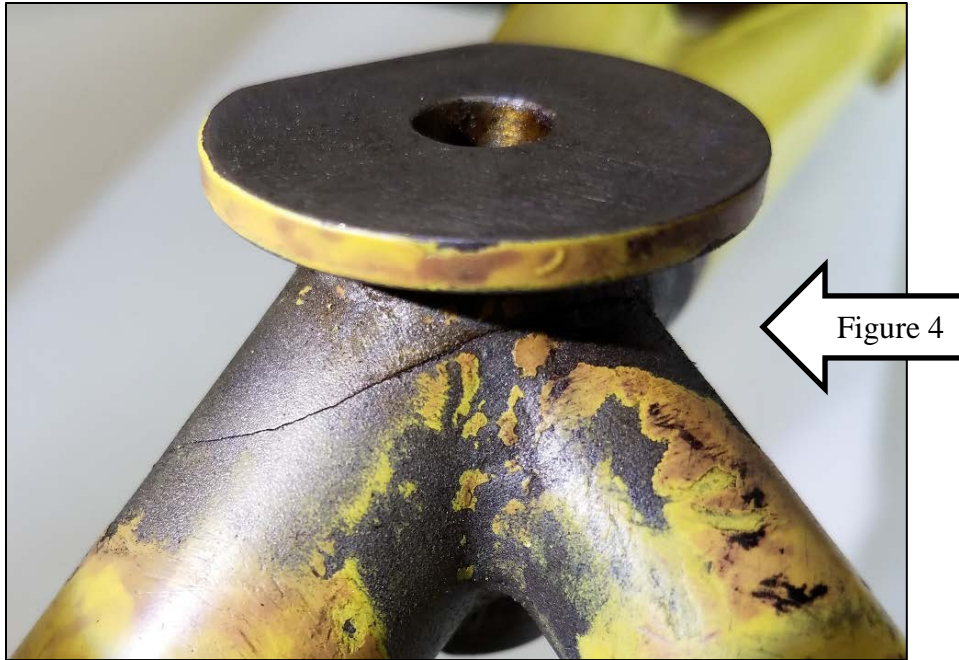
**Figure 5. Photograph of Cracked Area – Forward Left Mount - Rotated 90°
(Same area as is Figure 3 except mirror was not used; paint/epoxy primer removed)**
