ENSTROM HELICOPTER CORPORATION

SERVICE DIRECTIVE BULLETIN

SERVICE NOTE NO. 0028

Subject: Fuel Tank Vent Manifold

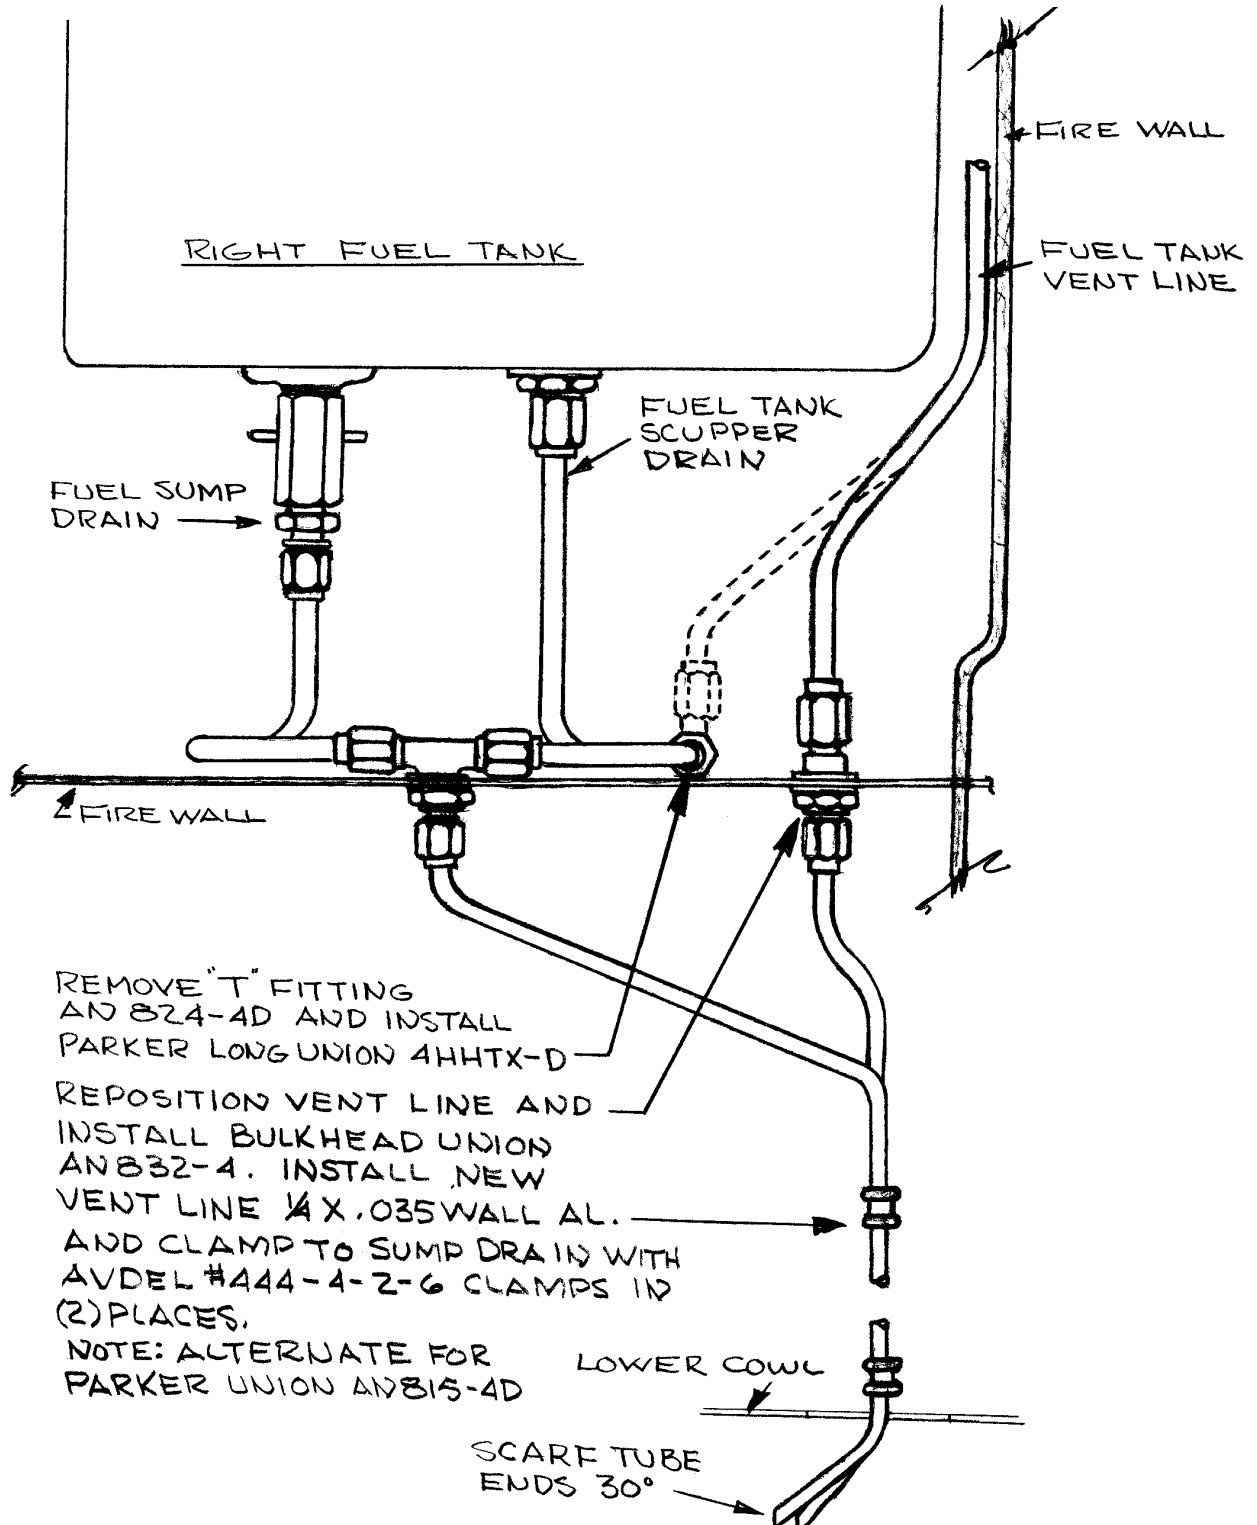
It has been reported that an Enstrom flying in rain experienced a slight fuel starvation problem. Upon checking the fuel tank vent system, it was found that the vent line was full of water, thus restricting airflow. Entry of the water was from the fuel tank scupper drain system.

To prevent reoccurrence of this condition, the modification illustrated on page two of this service note must be made at the owner's earliest convenience or at the next 100-hour inspection.

Field modifications can be made with approved hardware or modification kits can be acquired from Enstrom Customer Service Department.
