SERVICE DIRECTIVE BULLETIN NO. 0036

Subject: Main Rotor Shaft

Model: F-28A & 280

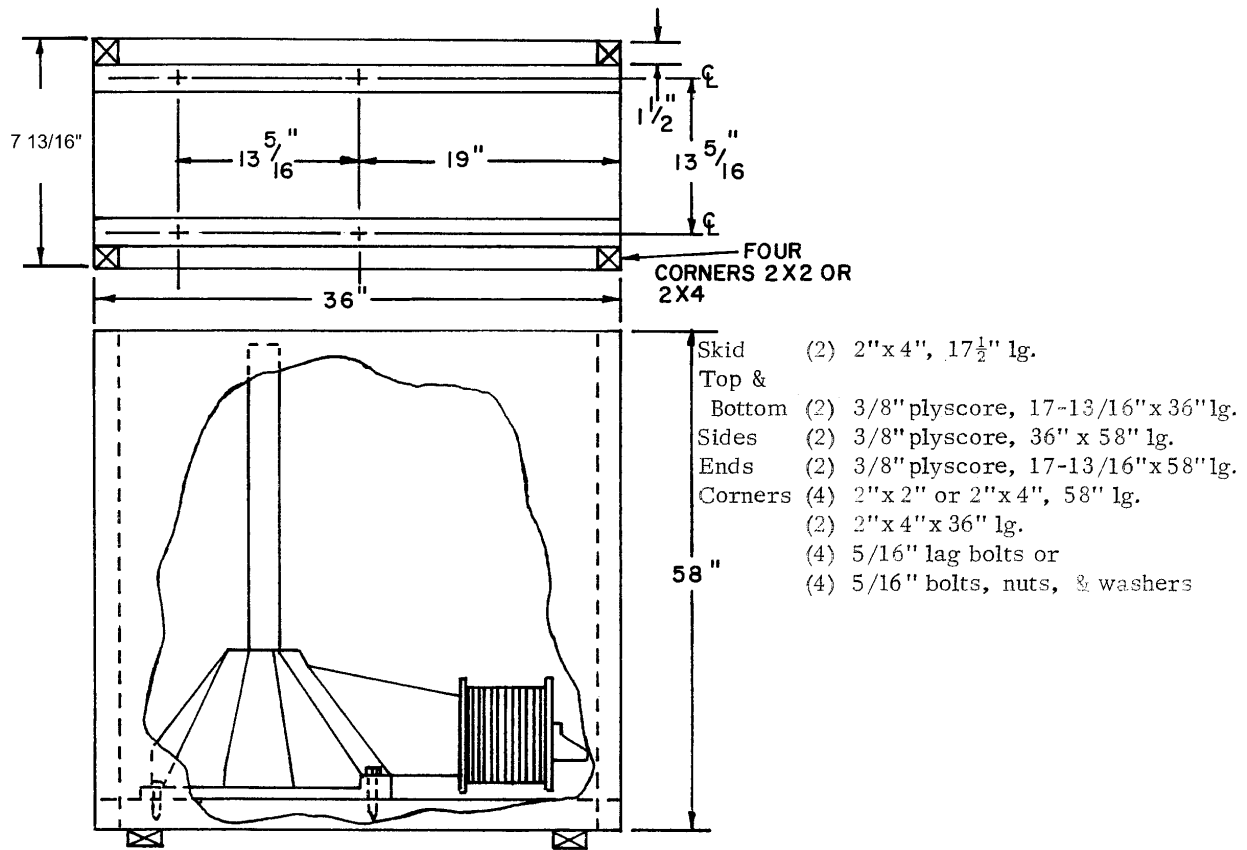
Care in packing transmissions for freight shipment is recommended to assure transportation damage does not occur. A sketch of a recommended packing method is shown below:
