SERVICE DIRECTIVE BULLETIN NO. 0040

Subject: Replacement of Wide Chord Tail Rotor Pitch Link Retainer Assembly, Part No. 28-16320; Guide Bolt, Part No. 28-16307.

Models: F-28C and 280C with Wide Chord (4.4 in. chord) Tail Rotors

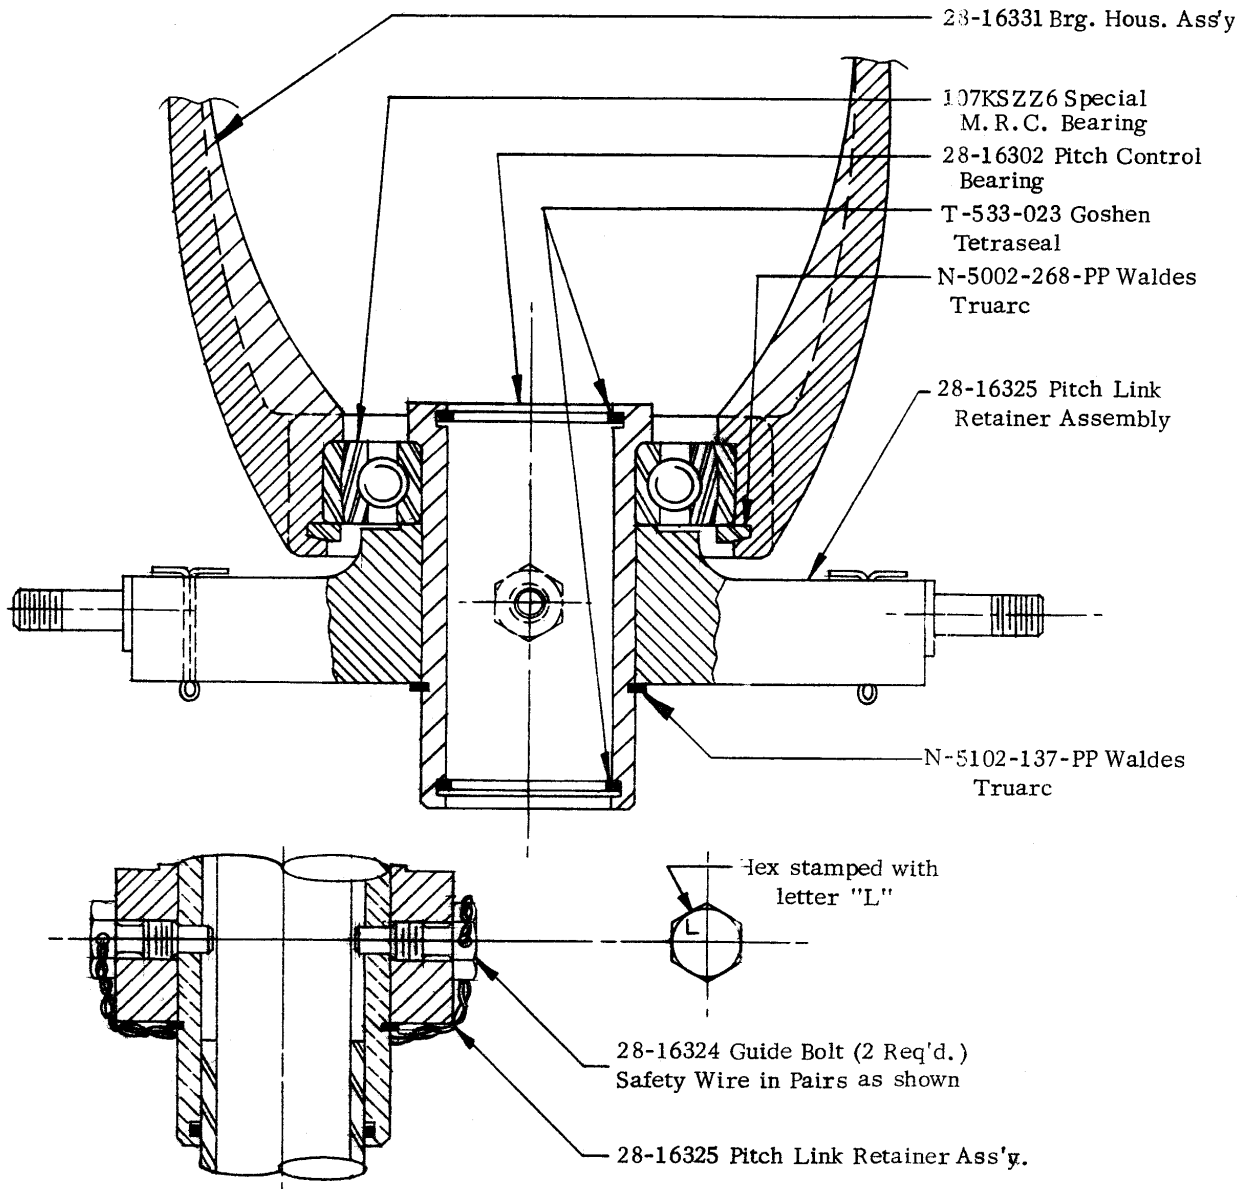
The following illustration clarifies the installation. Rigging is per Section 15 of the Maintenance Manual.

All owners and operators of affected aircraft are directed to perform a visual inspection of P/N 28-16320 prior to next flight, and prior to each flight thereafter. Replace this part within 100 flight hours after receipt of this notice with the new assembly, P/N 28-16325 (note that the longer guide bolts, P/N 28-16324, are required). After installation, further inspection in accordance with this bulletin is no longer required.
