**THE ENSTROM HELICOPTER CORPORATION**

## **SERVICE DIRECTIVE BULLETIN**

SERVICE DIRECTIVE BULLETIN NO. 0065  
REVISION B  
page 1 of 4

SUBJECT: Tail Rotor Driveshaft Spline Couplings, PN 28-13609

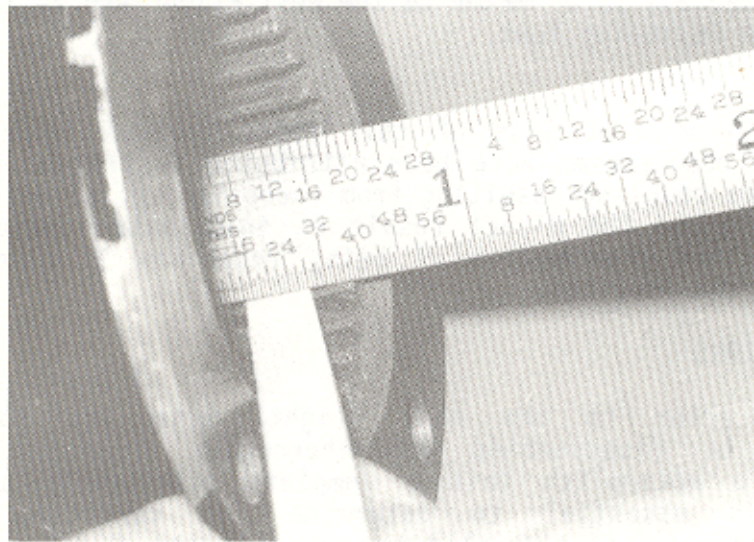
- A. The crown of the female coupling spline is approximately .040 inch in width. If the wear pattern is in excess of .010 inch, it is unairworthy and must be replaced by a serviceable component. The procedure to measure the wear on the female section splines is illustrated in Figure 1.

Figure 1. Checking inner spline wear on coupling.

**NOTE:** Tooth wear is measured by placing a 6 inch steel rule parallel to the crown at the top edge of the driven side. A piece of .125 x .010 inch shim stock is then placed between the tooth and the rule, and pressing the rule against the tooth, check if the shim can be removed. If the shim slips out, the coupling is to be rejected and replaced with an air-worthy component.

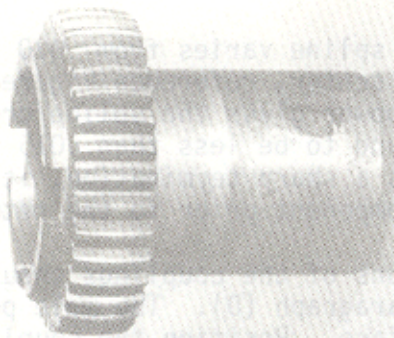
Figure 2. Checking outer spline wear on male coupling.

- B. The crown of the male coupling spline varies from .030 inch at the ends to approximately .020 inch at the center, reference Figure 2. By using a steel 1/100ths scale and a 10 power glass the spline crown should be measured at the center. If found to be less than .015 inch, and has rolled burrs on its edge or has a sharp termination, it must be rejected and replaced by an airworthy component prior to the return to service.

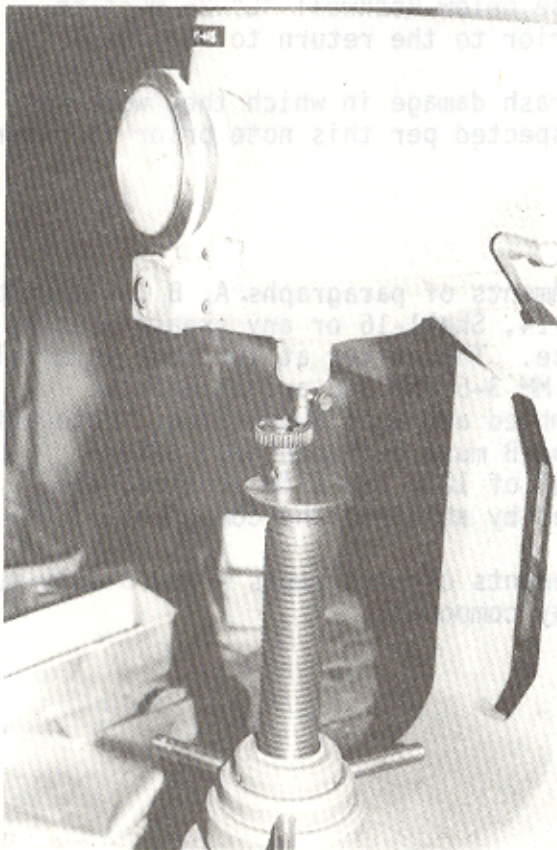
Figure 3.  
Checking hardness on male  
portion of coupling.

- C. Both the male and female portions of the couplings should be checked for material hardness, reference paragraph (D). The male portion should be checked on the inner circular face. Position the coupling half with the splined end and inner face looking up on the Rockwell machine support mandrel, making the inner face accessible, reference Figure 3. The female portion should be placed with its inner diameter over the mandrel and the attaching stub facing up. The end of the stub should be checked, reference Figure 4. Care should be taken when checking the hardness to properly support the components, and the surfaces to be checked should be clean and smooth. Three readings should be made on each half to obtain a good average on the Rockwell "C" scale. Components that average Rockwell "C" 25 or higher are acceptable; those below Rockwell "C" 25 must be replaced by an airworthy component prior to the return to service.

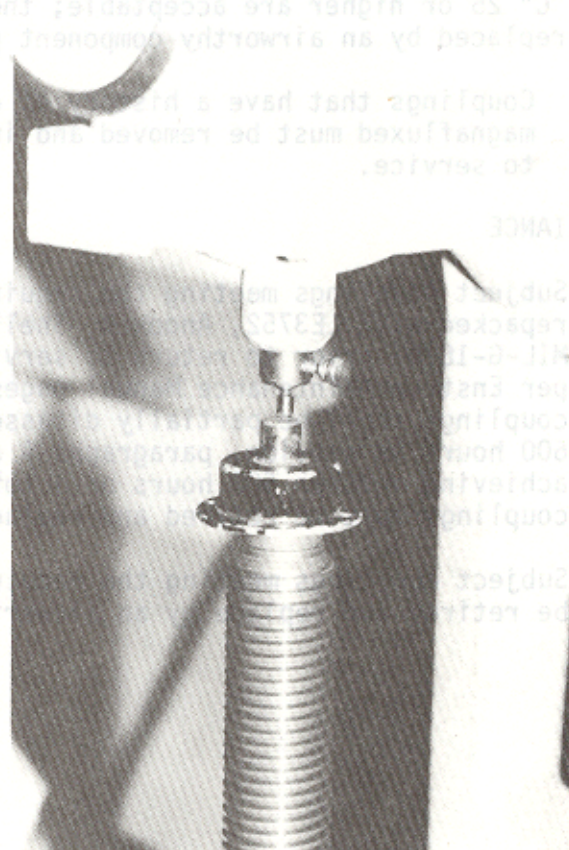
Figure 4.  
Checking hardness on female  
portion of coupling.
