### SERVICE DIRECTIVE BULLETIN NO. 0084

1. SUBJECT: Muffler Modification and Inspection

2. MODEL: F-28F, 280F, and 280FX

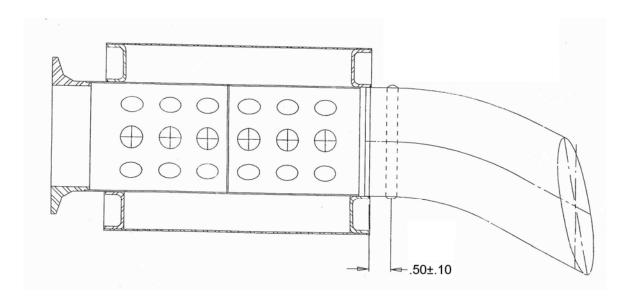
Figure 1: Muffler Modification

Enstrom received a report of an operator experiencing a sudden reduction in power during a landing approach. The operator was able to land without incident. Upon removal and inspection of the muffler, it was found that an internal baffle had failed and when it came loose it partially blocked the exhaust outlet causing the sudden reduction in power. The original release of this Service Directive Bulletin mandated a one time and repetitive inspections to detect cracks and/or deformities in the muffler end plate and liner and replacing the muffler with an airworthy muffler or tail pipe if cracks or deformities were found. The muffler was redesigned to prevent an internal baffle failure from blocking the exhaust outlet. The part number for the muffler with the redesigned internal baffle was ENX-0001, Rev. B.

The muffler modification does not prevent failure of the internal baffle, but it does prevent a significant loss of power due to exhaust blockage as a result of failure of the internal baffle.

- 1. Remove the muffler from the aircraft.
- 2. Modify the muffler in accordance with the instructions below. Note: Instructions are also provided with the modification kit, P/N ENX0001R.
  - a. Drill two holes, 0.25" diameter, 180 degrees apart, as shown in Figure 1, for the 0.25" diameter rod. (The radial location around the tailpipe tube is optional.)
  - b. Install the rod through the tailpipe tube ensuring the rod ends are positioned in the hole openings. TIG-weld each rod end to the tailpipe tube using the kit-supplied welding rod.
- 3. Reinstall the muffler.
