THE ENSTROM HELICOPTER CORPORATION

SERVICE INFORMATION LETTER NO. T-030

1. SUBJECT: Main Rotor Gearbox Bolt Retorque

2. MODEL: TH-28, 480, and 480B

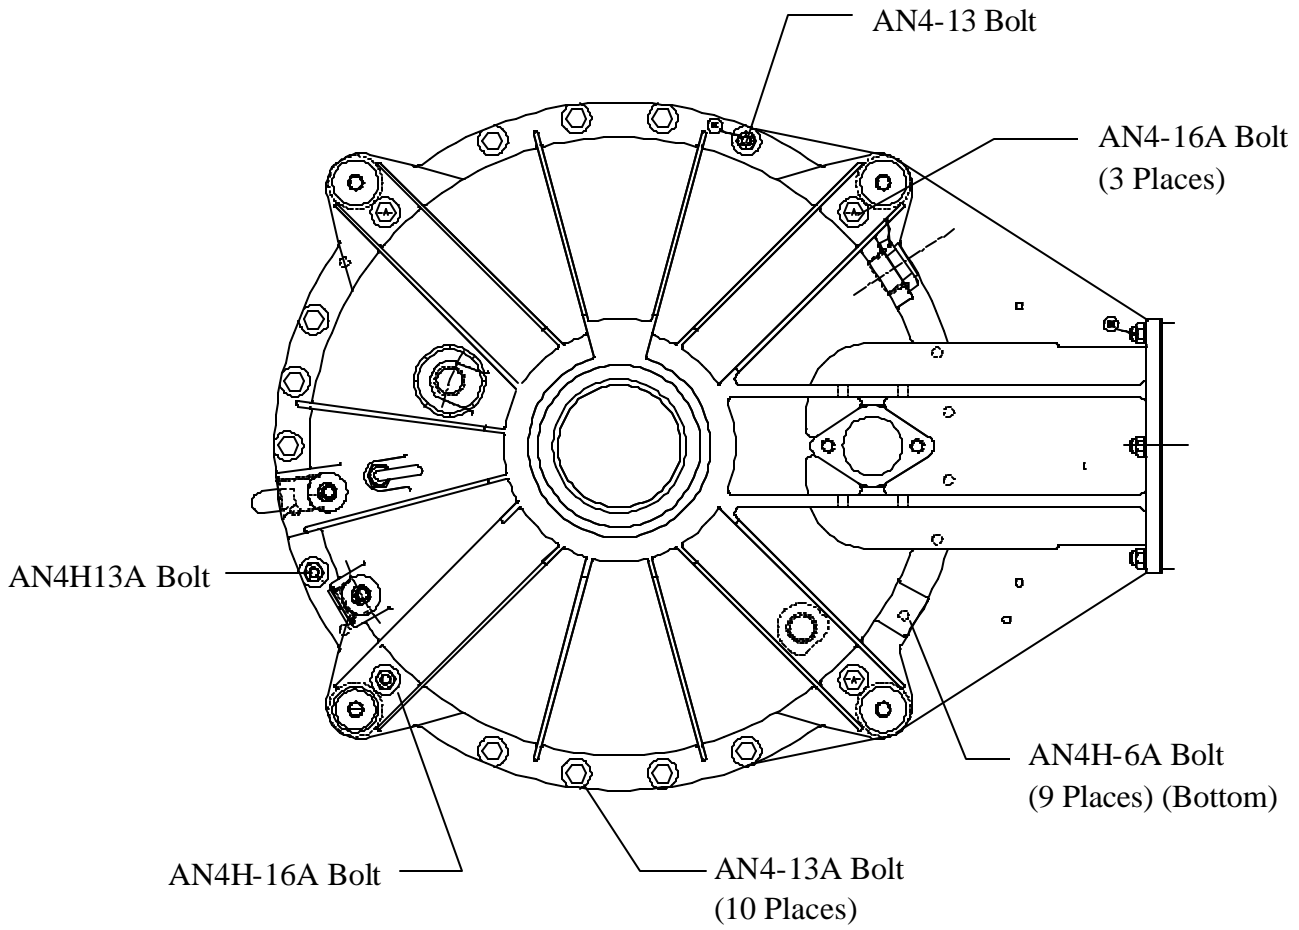
Figure 1. Main Rotor Gearbox Attachment Bolts

Enstrom has determined that deterioration of epoxy primer in the area of the bottom cover attachment hardware may cause these fasteners to lose torque. This could result in leakage and fretting at the housing bottom cover.

- A. Locate the main rotor gearbox bottom cover attachment bolts (reference Figure 1).
 - B. Remove safety wire.
 - C. Remove lead seal as required and note on the component record card that the SIL was complied with and the lead seal was removed.
 - D. Retorque each referenced nut and bolt to 100 in-lb.
 - E. Safety wire bolts.
 - F. If the torque has not changed, no further action is required.
 - G. If the torque has changed, retorque again at the next scheduled inspection.
- 5.2. PARTS: MS20995-C32 Safety Wire, As required.
6. SPECIAL TOOLS: None
7. MAN-HOURS: 2-4 Man-hours
8. WARRANTY: Per Enstrom New Helicopter Warranty policy.
9. WEIGHT CHANGE: None
10. LOG BOOK ENTRY: As required for maintenance actions.
11. REPETITIVE ACTION: See 5.1.G.
