SERVICE INFORMATION LETTER NO. 0090

Subject: Fuel Nozzle Air Vent Modification

Models: F-28C, 280C

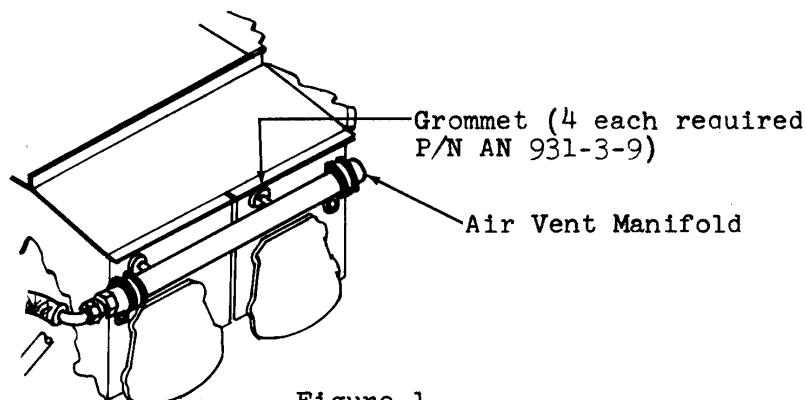
Figure 1

There exists the possibility of failure to the air vent manifold assembly in the area of the small tube attachment, (due to lack of cushion in the grommet where the tube passes through the engine baffle). This manifold is located on either side of the engine and just above the rocker box covers. Reference Figure 1.

In order to reduce the possibility of failure to the nozzle air vent manifold the following corrective procedure is recommended.

1. Loosen clamps that secure rubber hose from fuel nozzle and slide hose from the nozzle vent manifold tube.
2. Remove the nozzle vent manifold assembly left and right by removing screws from clamps at either end of manifold.
3. Remove the old rubber grommet from the engine baffle and enlarge the hole to .56".
4. Install new rubber grommet P/N AN931-3-9 in the enlarged hole.
5. Reinstall the air manifold assemblies and reconnect the nozzle air vent hose from fuel nozzle.
