SERVICE INFORMATION LETTER NO. 0142

1. SUBJECT: New Tail Rotor Assembly Bumpers

2. MODELS: F28C, 280C, F28F, 280F, and 280FX

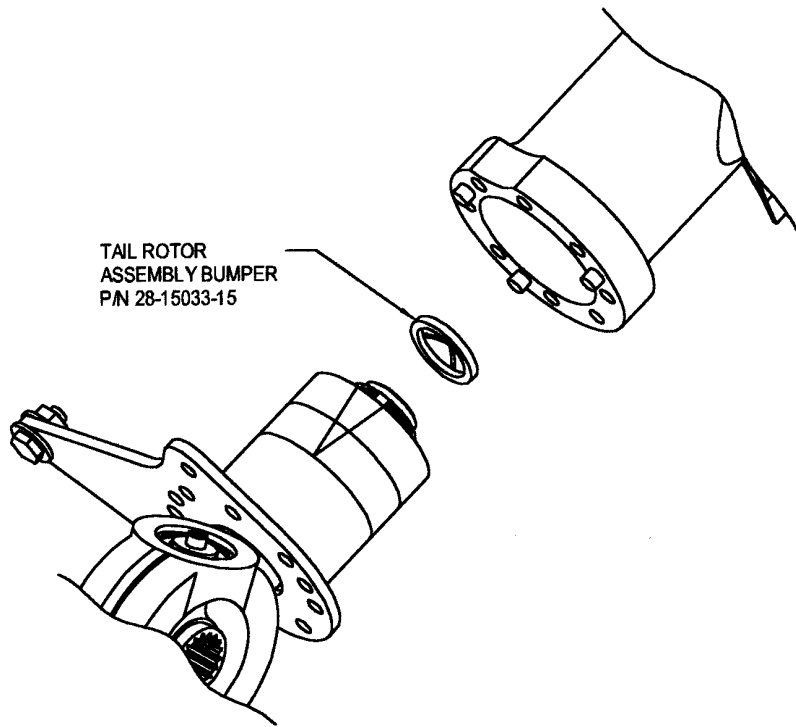
Figure 1

Previously, Enstrom changed the stock material from which the tail rotor assembly bumpers are manufactured. This change was initiated to prevent the “dead spot” in the tail rotor control system that can occur when the bumpers swell because of grease contamination. Since changing the bumper material, Enstrom has received several reports of the “dead spot” occurring with the cause of the “dead spot” traced to the new bumpers. Enstrom has designed new bumpers, P/N 28-15033-15, to replace the rubber bumpers. The new bumpers are manufactured from polyethylene plastic.

Maintenance technicians should note that the “dead spot” in the tail rotor control system can also be caused by low tail rotor cable tension, notchy feathering bearings in the tail rotor, or binding in the slider assembly.

B. Replace the 28-15033-13 bumpers with the new 28-15033-15 bumpers anytime the tail rotor assembly is disassembled (Refer to Figure 1). Replace the tail rotor bumpers using the procedures found in the applicable maintenance manual for the helicopter with the exception that the bumpers are not glued onto the end of the spindle.
