SERVICE DIRECTIVE BULLETIN NO. 0097

1. SUBJECT: Incorrect Installation Hardware on Seat Belt Bracket, P/N 28-11467-1
2. MODEL: F-28F, 280F, and 280FX
3. EFFECTIVITY: All F-28F serial numbers prior to S/N 816
All 280F serial numbers
All 280FX serial numbers prior to S/N 2108

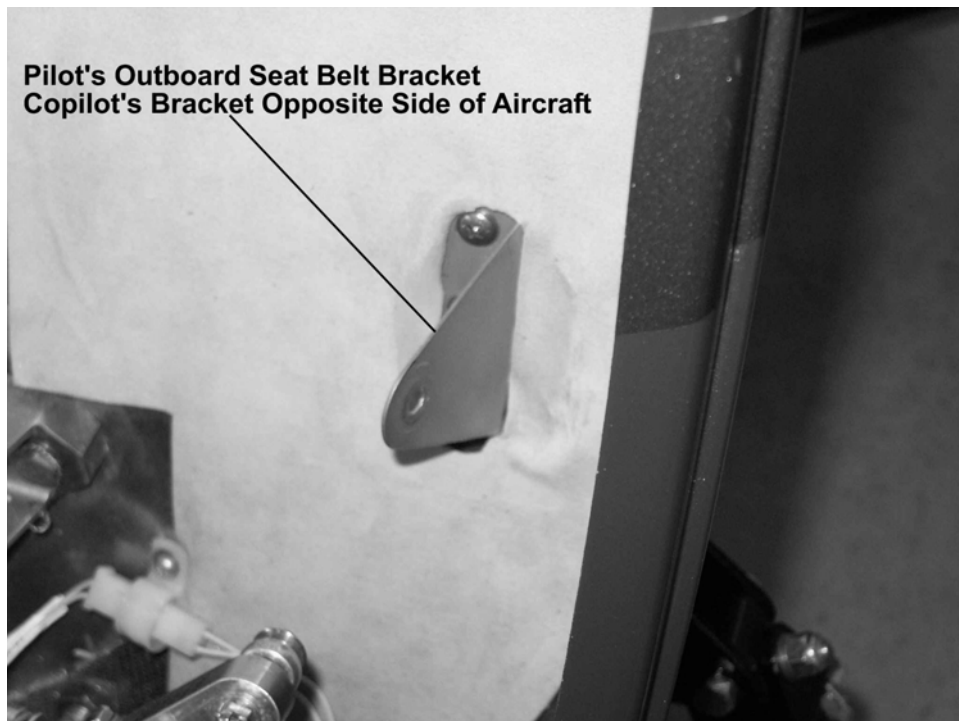
Figure 1. Seat Belt Bracket Location

- A. Remove the seat backs and cushions.
- B. Remove the fiberglass seat deck.
- C. If required for access, remove the outboard portion of the pilot's and copilot's seat belt assemblies.
- D. If required, lift up the backwall upholstery to gain access to the seat belt brackets (See Figure 1).

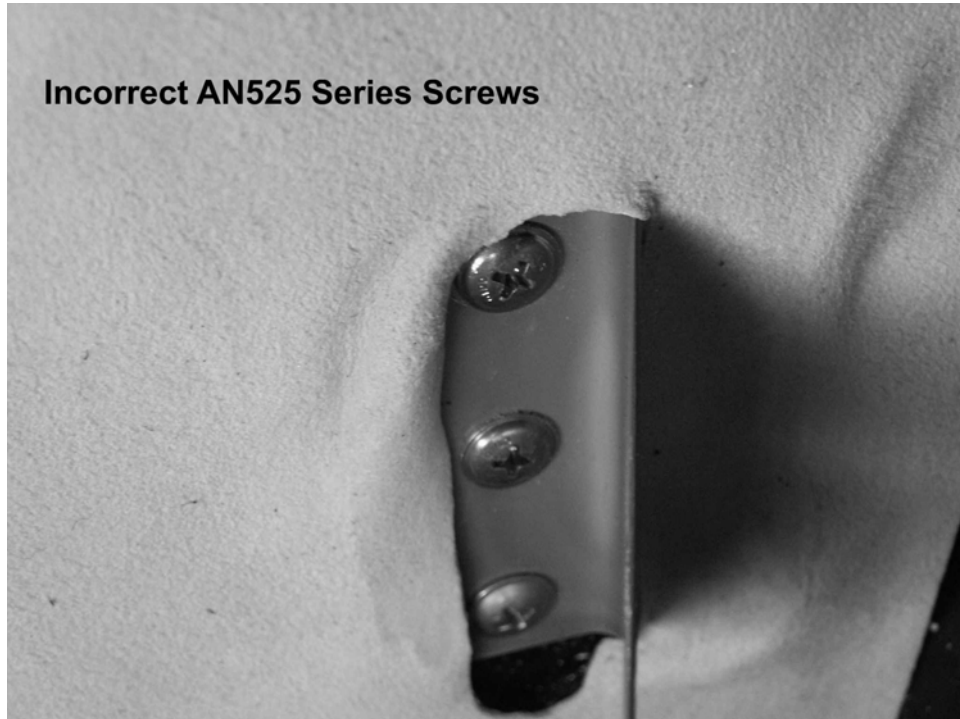
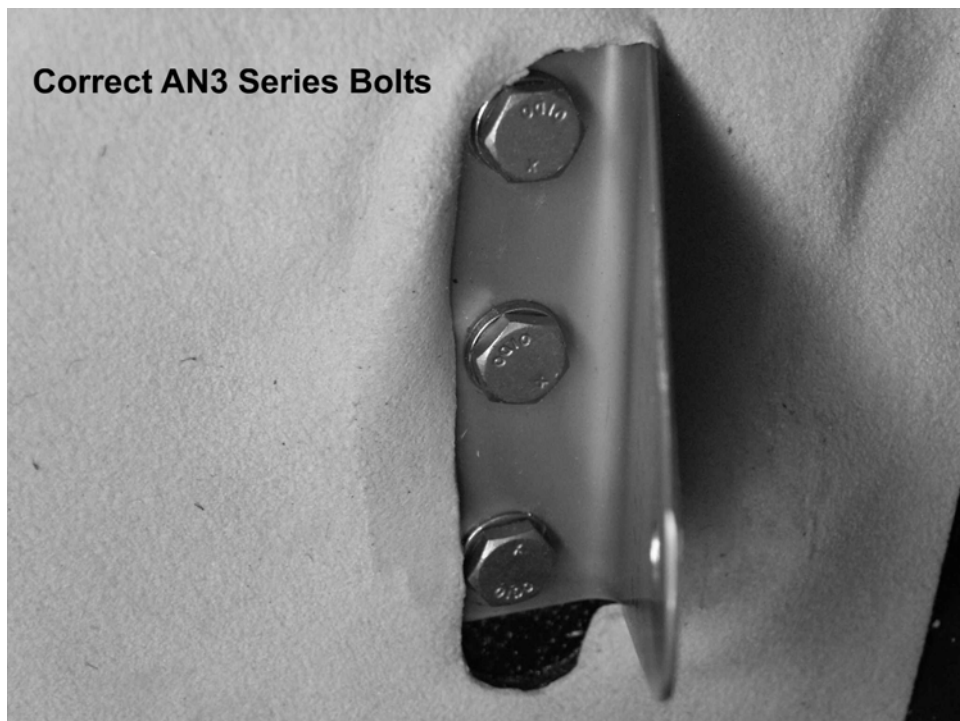
Figure 2. Seat Belt Bracket Installation Hardware

During final inspection of a production F-28F aircraft, an inspector found the seat belt brackets, P/N 28-11467-1, installed with AN525 series screws instead of the AN3 series bolts required by the engineering drawings. A review of the production records did not establish how many aircraft potentially have incorrect hardware installed.

The AN525 series screws are authorized for the remaining hardware in the backing doubler for the seat belt bracket.

- E. Inspect the seat belt bracket installation for the correct hardware (See Figure 2).
- F. If AN3 series bolts are installed in the seat belt brackets, reassemble the aircraft and return it to service.
- G. If AN525 series screws are installed in the seat belt brackets, remove the screws and replace with AN3-5A bolts and AN960-10 washers. After replacing the hardware, reassemble the aircraft and return it to service.

Description	Part Number	Quantity
Bolt	AN3-5A	6 Ea
Washer	AN960-10	6 Ea
