# SERVICE DIRECTIVE BULLETIN

SERVICE DIRECTIVE BULLETIN NO. 0128

1. SUBJECT: Copilot Collective – Retention Pin Installation
2. MODEL: F-28, F-28A, 280, F-28C, F-28C-2, 280C, F-28F, 280F, and 280FX (does not apply to F-28C-2R and F-28F-R unless the aircraft has been modified to a left-hand pilot in command configuration)
3. EFFECTIVITY: All aircraft models equipped with the quick release collective retention pin; Serial numbers are as follows:

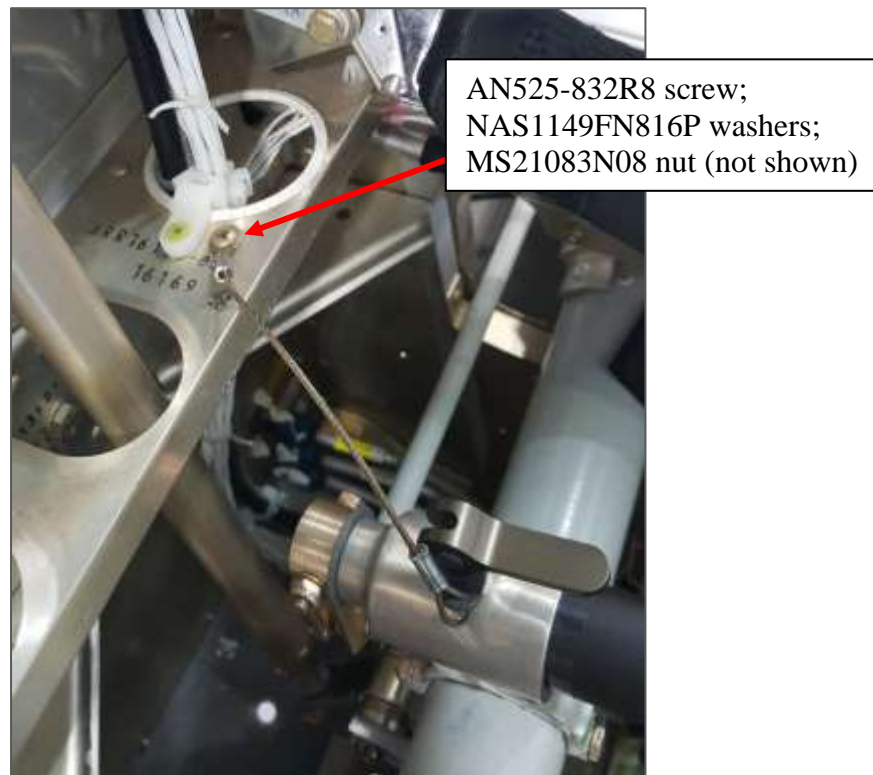
*Figure 1. Former Retention Pin Lanyard Installation*

6.2 Remove the existing hardware attaching the lanyard to the seat structure (Figure 1).

**NOTE: Use care when removing hardware to avoid dropping parts into the controls.**

6.3 Retain the retention pin and lanyard.

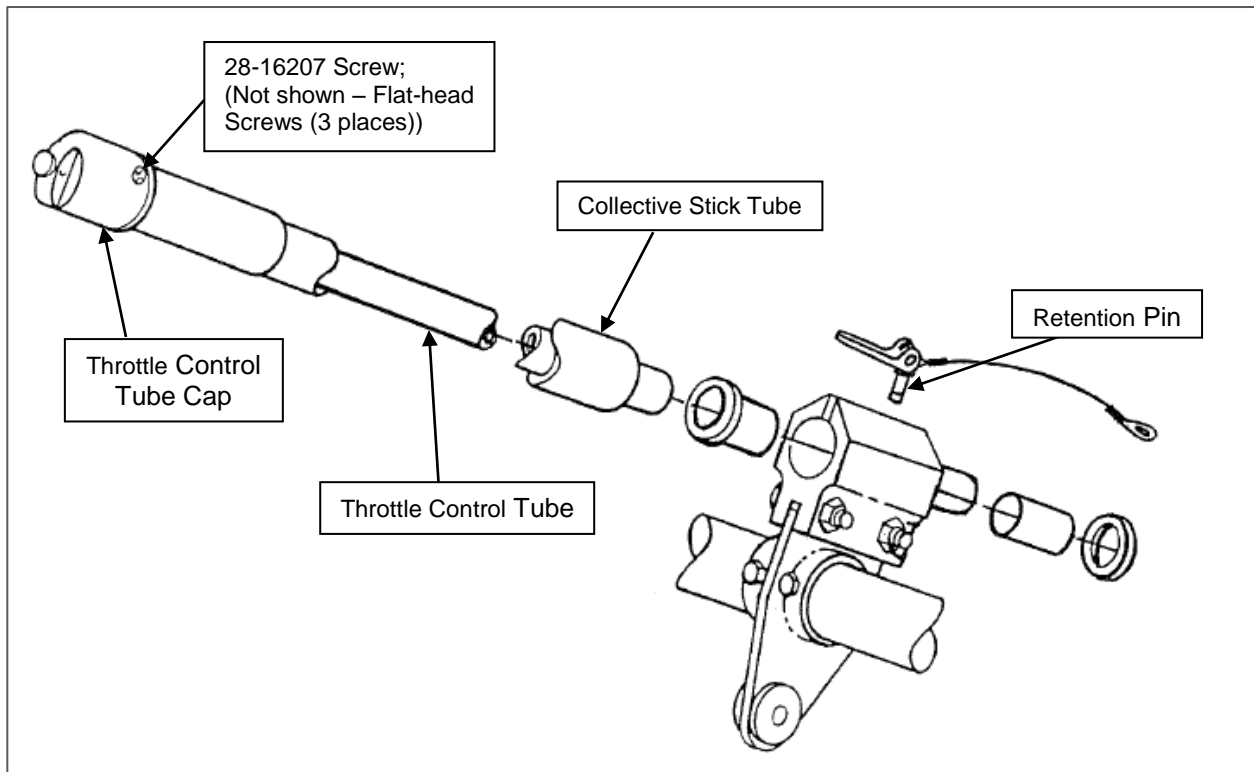
Figure 2. Collective Stick Assembly (F-28, F-28A, 280 models)

## 6.4.1 Disassembly (F-28, F-28A, and 280 models) (Figure 2):

**NOTE: It is recommended to mark the location of screw (28-16207) prior to removal.**

6.4.1.1 Remove screw (28-16207) and flat-head screws (3 places) from the throttle control tube cap.

6.4.1.2 Push the throttle control tube assembly through the forward end of the collective stick.

- 6.8 Reassemble the collective stick assembly.
  - 6.8.1 Reassembly (F-28, F28A, and 280 models) (Figure 2):
    - 6.8.1.1 Install the throttle control tube into the collective stick tube.

- 6.8.1.2 Install screw 28-16207 at marked position (if applicable) into the cap of the throttle control tube assembly.
    - 6.8.1.3 Install the screws (3 places) into the throttle control tube cap.

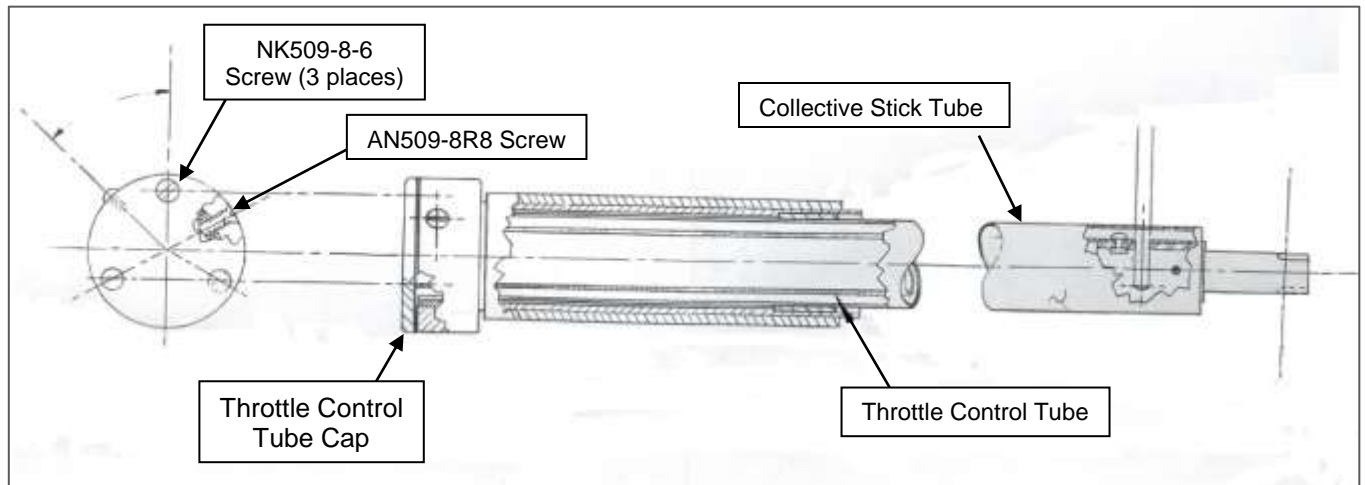
Figure 3. Collective Stick Assembly (all other models)

## 6.4.2 Disassembly (all other models) (Figure 3):

6.4.2.1 Remove screw (AN509-8R8) from the throttle control tube cap assembly.

6.4.2.2 Remove screws (3 places) from the cap.

6.4.2.3 Push the throttle control tube assembly through the forward end of the collective stick.

- 6.8.1.5 Ensure that there is no contact of the throttle control tube with the rivet.
- 6.8.2 Reassembly (all other models) (Figure 3):
  - 6.8.2.1 Install the throttle control tube into the collective stick tube.

- 6.8.2.2 Align the throttle control tube with the slot in the collective stick tube.

6.8.2.3 Install screw AN509-8R8 into the cap of the throttle control tube assembly.

6.8.2.4 Install the screws (3 places) into the throttle control tube cap.

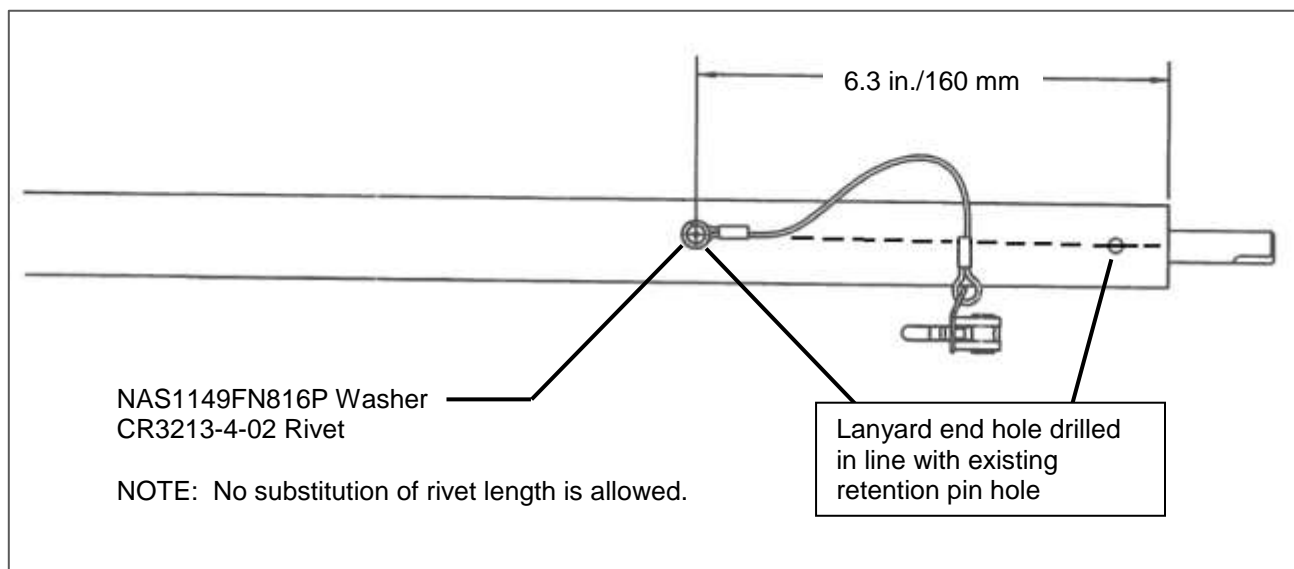
Figure 4. Lanyard Mount Hole Location

- 6.5 Drill a  $\text{Ø}0.129/0.132$  hole through the wall of the collective stick in the location shown in Figure 4. Deburr the hole.

**WARNING:** Ensure the collective stick is free of debris. Throttle operation may be impaired if debris is not removed.

- 6.6 Remove all debris from the interior of the collective stick.

**WARNING:** Ensure the rivet is the correct length. Improper rivet length and/or rivet installation could interfere with the throttle operation.

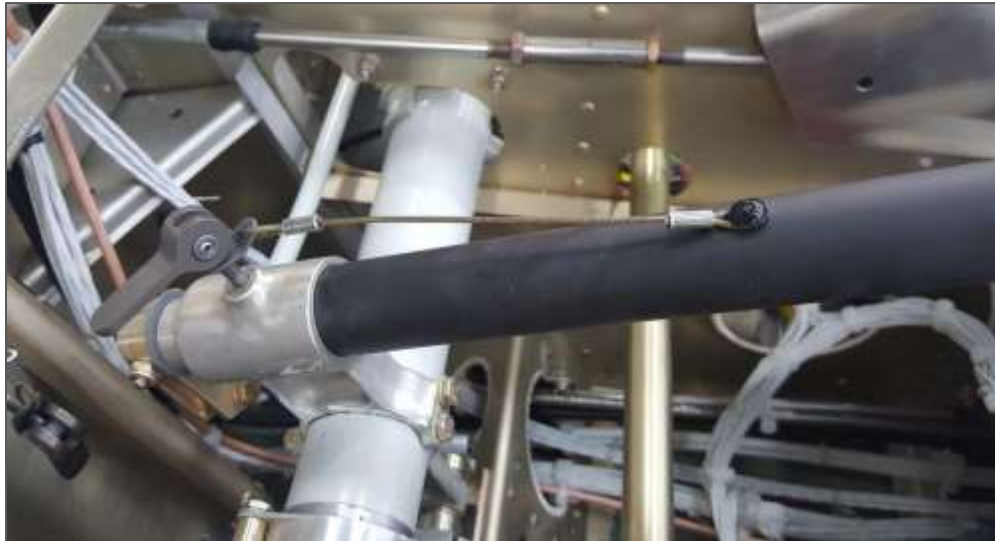
Figure 5. Lanyard Installed on Collective Stick

- 6.7 Install retention pin lanyard to the collective stick using NAS1149FN816P washer and CR3213-4-02 rivet. The washer and rivet may be painted a semi-flat black.

- 6.7.1 Install washer onto rivet.
- 6.7.2 Insert rivet through lanyard keyhole and install into drilled hole to attach the lanyard to the collective stick.
