SERVICE INFORMATION LETTER

SERVICE INFORMATION LETTER NO. 0052 Page one

Subject: Improved Narrow-Chord Tail Rotor Spindle Design

Models: F-28A, 280, and "C" Models

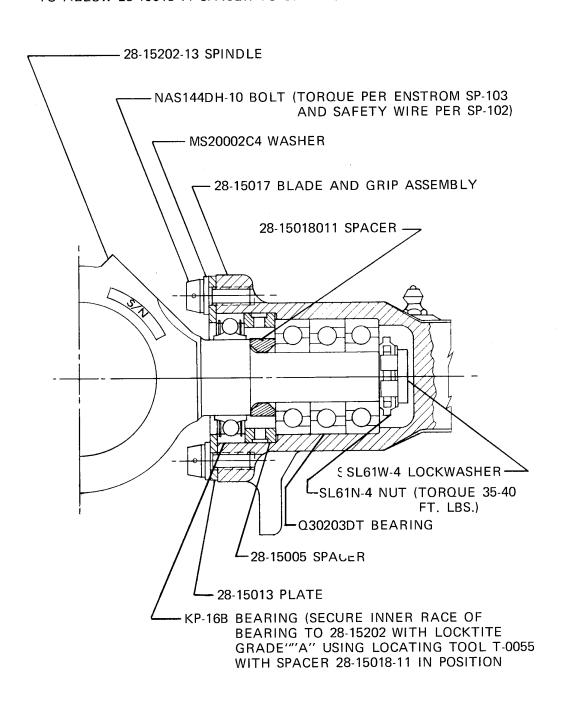
Effectivity: Component S/N 090-76ST and Up as Identified at Location on illustration

The tail rotor spindle, Enstrom P/N 28-15018, for the narrow-chord tail rotor grip blade assembly, P/N 28-15017, has been redesigned to essentially double the fatigue strength of the spindle, thus providing an additional margin of safety in the event the torque is lost on the spindle retention nut. The redesign consisted of lengthening the small spindle diameter, increasing the radius to the larger diameter or bearing shoulder, and shot-peening the radius. A bearing spacer that is double-chamfered was added to the assembly to compensate for the length difference and radius clearance required.

When disassembling or assembling tail rotor spindles S/N 090-76ST and up, special care should be taken to include the spacer, P/N 28-15018-11, when tool No. T-0055 is used to locate and position #KP-16B bearing on the spindle. The complete assembly is illustrated on page 2 for your reference.

NOTE: IF COUNTERBORE OF T-0055 POSITIONING TOOL WILL NOT RECEIVE SPACER, COUNTERBORE ON TOOL SHOULD BE OPENED SLIGHTLY TO ALLOW 28-15018-11 SPACER TO SLIP IN.
